Contract No. DTRS56-03-T-0003
5th Quarterly Status Report (Project #1) - REVISED
Period: April 1, 2004 to June 30, 2004

Quarterly Status and Progress Report
Improvements to the External Corrosion Direct Assessment
Methodology by Incorporating Soils Data
Agreement DTRS56-03-T-0003
5th Quarterly Status Report - *Revised*
April 1, 2004 to June 30, 2004

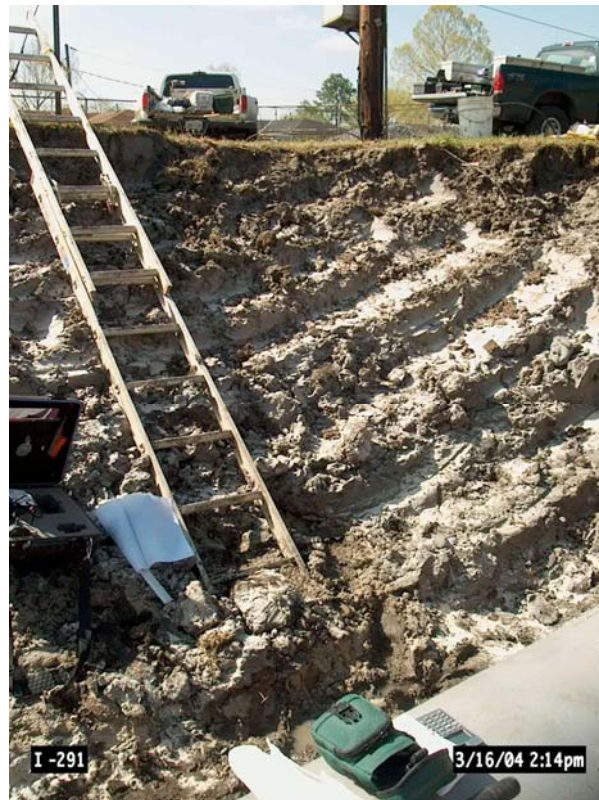
The topography and site position were level at this location. The soil consisted of imperfect to poorly drained fluvial silt shown in Photo 1. Gleying of the soil occurred from 29.5 in. to the depth of the excavation. Ground water seepage occurred within the excavation at 61.0 in below the ground surface. Ground water was also observed seeping at the pipe location, 49.5 in. below ground surface. No carbonates were present in the excavation.

Photo 1: Fluvial Silt Soil Profile

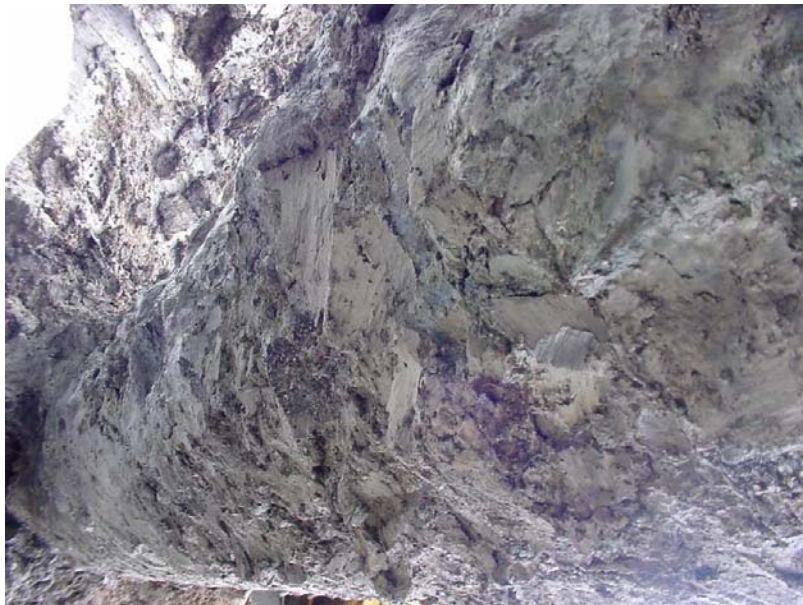
After the pipe was exposed, the coating was examined for general condition and disbondments. At the direction of personnel from Operator E, the coating was then removed on joint AA to accommodate corrosion documentation, exposing the steel surface of the pipe at the disbonded coating locations. The coating damage was caused by soil stress.

Photo 2: Coating Conditions

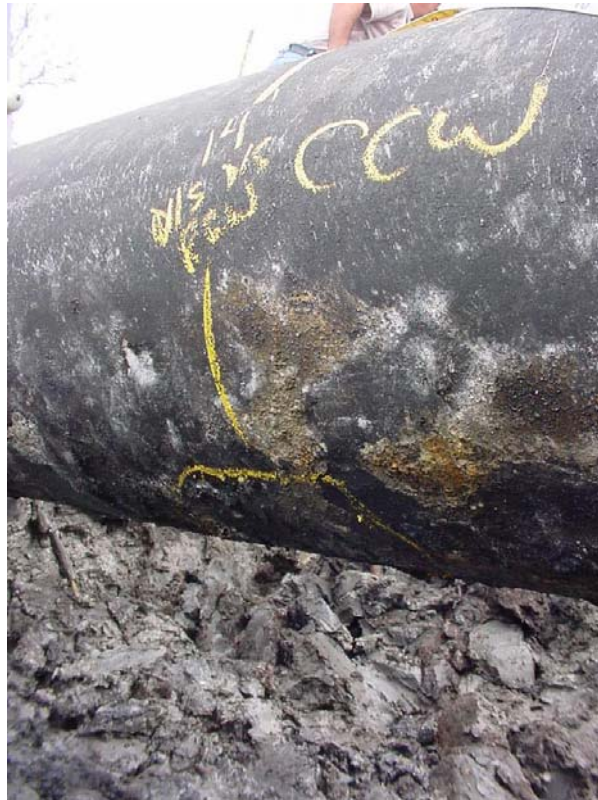
Soil Removed from Pipe	Joint AA: From 0 ft 0 in. to 22 ft 5.8 in. U/S of the RGW for 360 Degrees Joint A: From 0 ft 0 in. to 1 ft 3.6 in. D/S of the RGW from 12:00 o'clock to 3:00 o'clock Total Length of Uncovered Pipe: 23 ft 9.4 in.
Coating Inspected	Joint AA: From 11 ft 1.1 in to 22 ft 5.8 in. U/S of the RGW for 360 degrees Total Length of Coating Inspected: 11 ft 4.7 in.
Coating Condition	Joint AA: Fair Joint A: Excellent
Coating Removed	Joint AA: From 11 ft 1.1 in to 22 ft 5.8 in. U/S of the RGW for 360 degrees Total Length of Coating Removed: 11 ft 4.7 in.
Corrosion Deposits	Spotty deposits of scaly, orange FeO/OH Intermittent deposits of filmy, white CaCO ₃ Intermittent deposits of pasty, white FeCO ₃
Electrolyte (pH Value)	7.0

Photo 3: Typical Corrosion Deposits

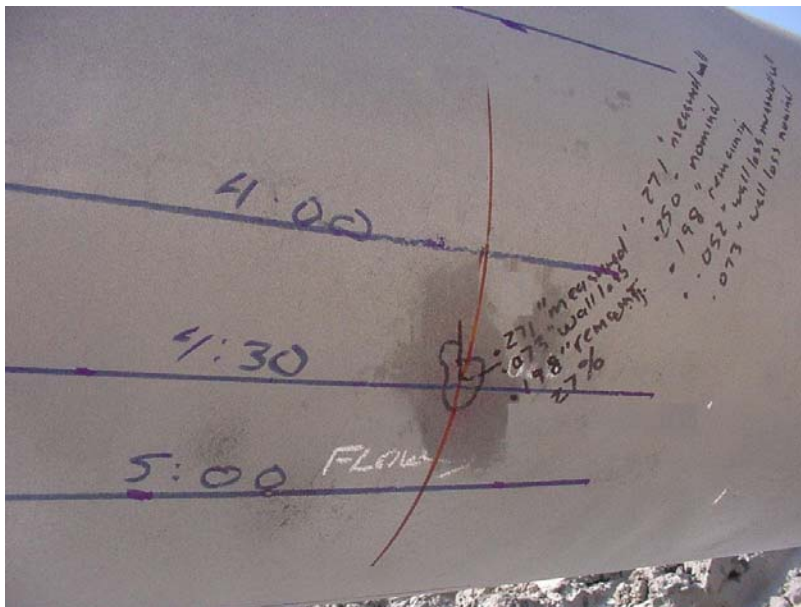
Two anomalies listed in the CPIG tool log were correlated in the field as two external corrosion features. A third party company used a pit gauge to determine the depths of the external corrosion features. An engineering assessment utilizing ASME B31G was performed by Operator E personnel. The two external corrosion features passed the engineering assessment and were blasted and recoated under the directions of Operator E personnel.

Photo 4: Feature 3614

The pipe surface where coating was removed was recoated with RD6 Mesh Tape. Following the completion of the investigation, the pipeline was deemed safe and reliable for continued service by Operator E personnel.

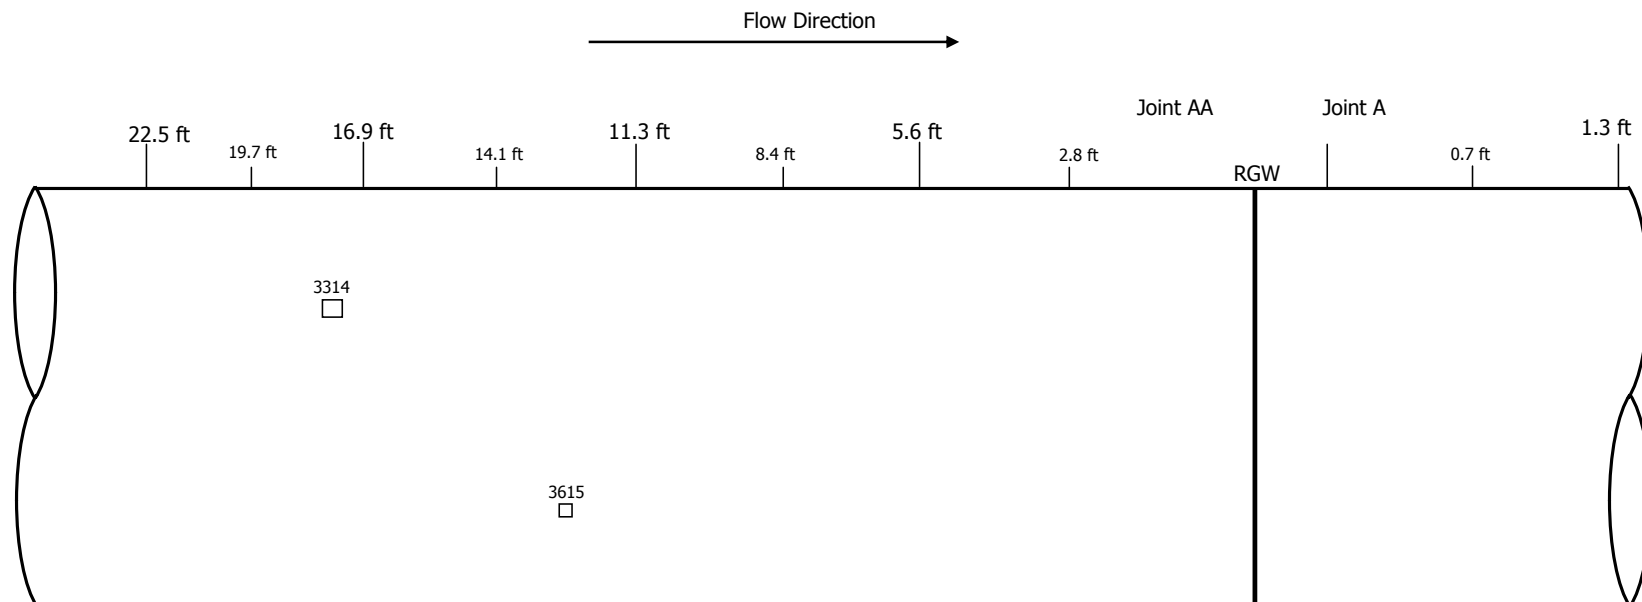
Feature Identification	From (ft)	To (ft)	By (in.)	At (in.)	Clock Pipe Position	Length (in.)	Depth (%)
External Corrosion	17.0	17.1	1.0	18.7 CW	1:55	1.2	26.9
External Corrosion	13.62	13.65	0.2	8.1 CW	4:30	0.4	33.9
